Adhesion of dual-cure resin cement to ceramic: Action of ceramic primers

Fixed Prosthodontics
Department of Restorative Sciences
Faculty of Dentistry
Tokyo Medical and Dental University

This thesis is submitted in partial fulfillment of the requirements for
the degree of Doctor of Philosophy in Dental Science

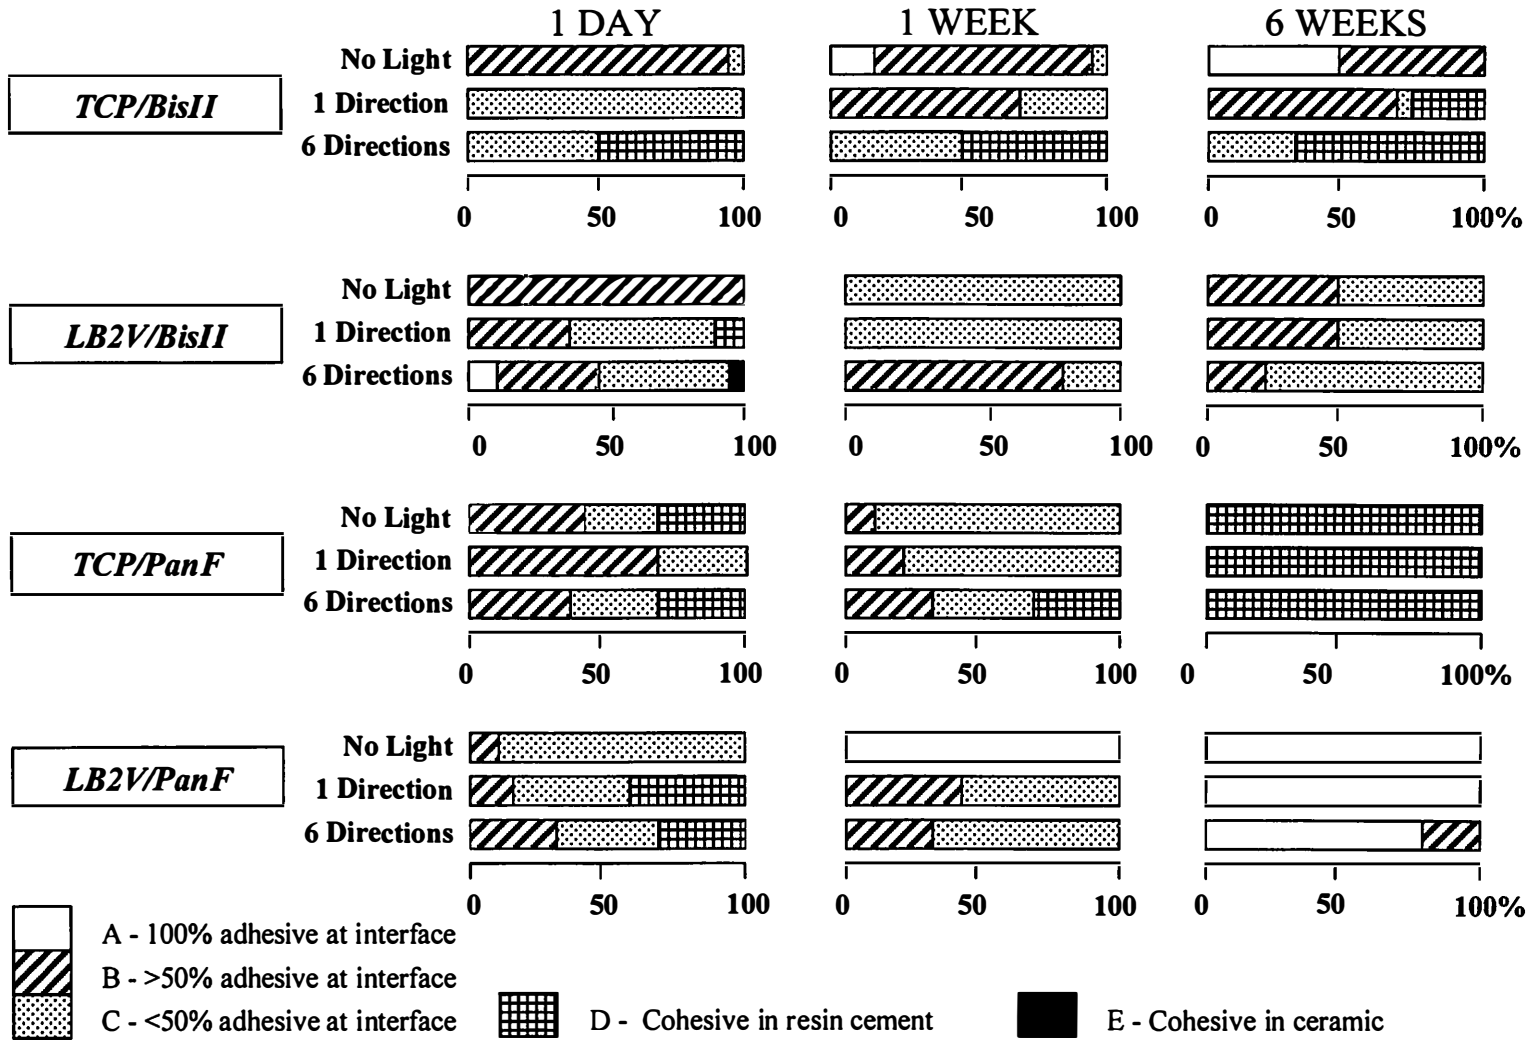
Figure 2. Classification of specimen failure mode

Failure mode was classified as: A, 100 % adhesive failure at the bonded interface; B, more than 50% adhesive failure of the resin cement at the bonded interface; C, less than 50% adhesive failure of the resin cement at the bonded interface; D, cohesive failure within resin cement; and E, cohesive failure within ceramic.

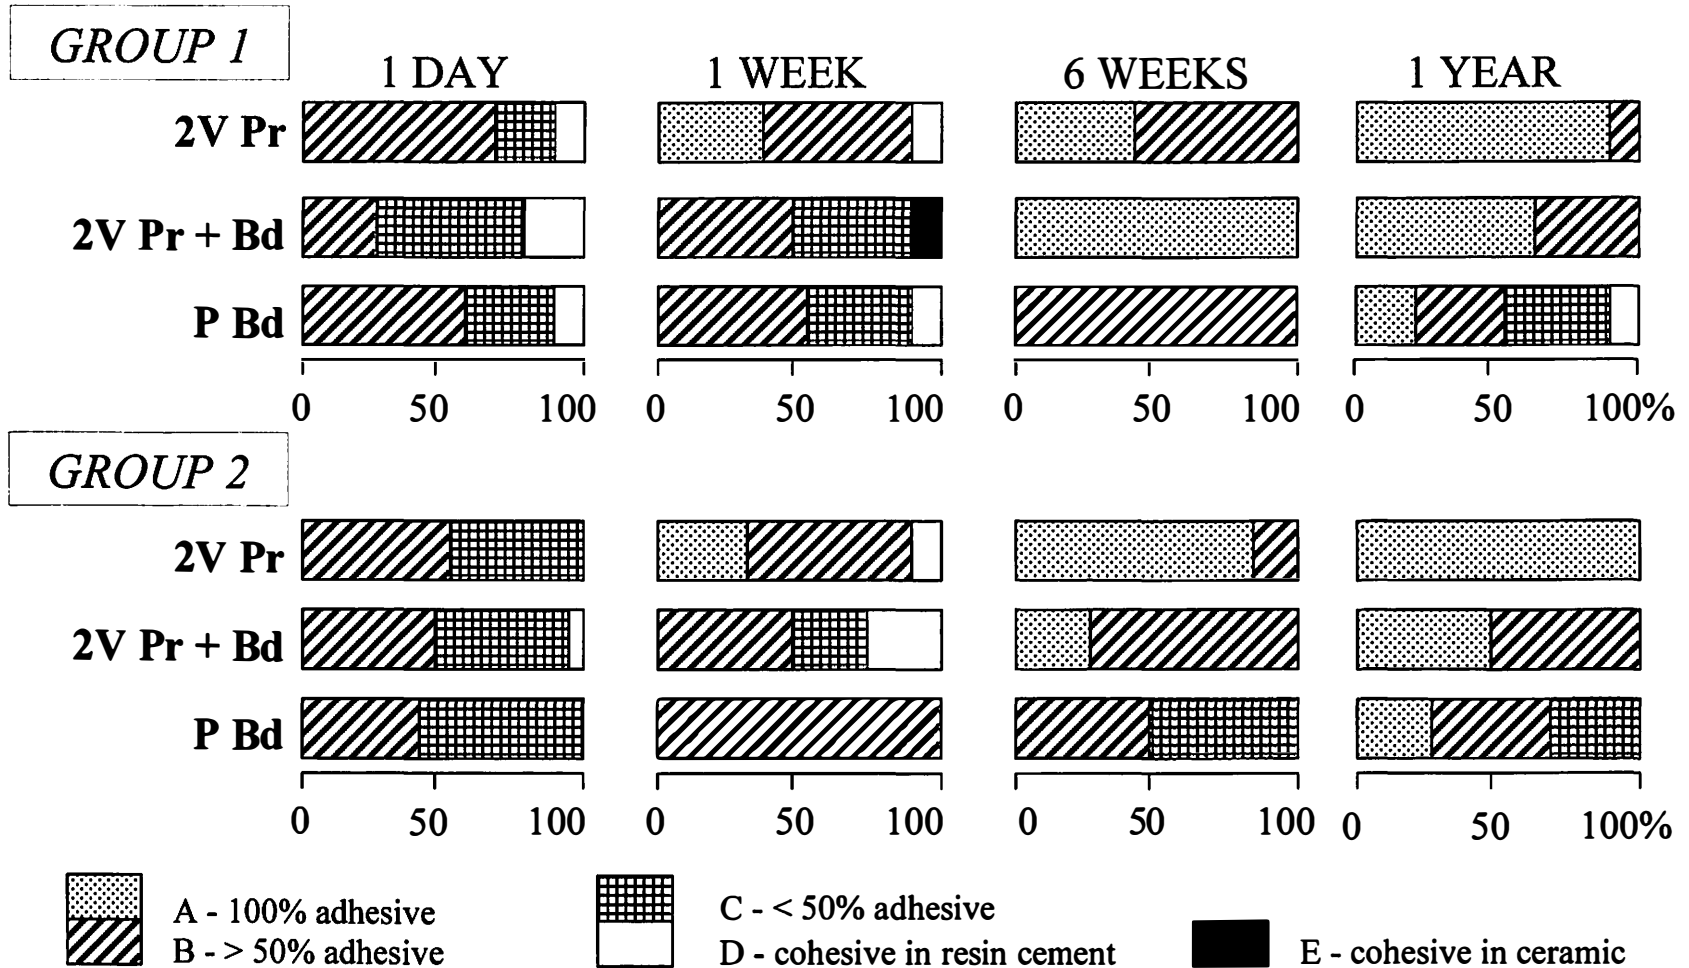
Figure 2. Classification of specimen failure mode

The failure modes of the beams are shown in figure 2. Regarding Group 1, after one day of water storage, all three sub-groups exhibited roughly similar percentages of greater than and less than 50% adhesive failure at the resin-ceramic interface and cohesive failure in resin. However, for all three sub-groups, there was a decrease in the percentage of cohesive failures in resin and an increase in the number of complete adhesive failures over time. Figures 3a

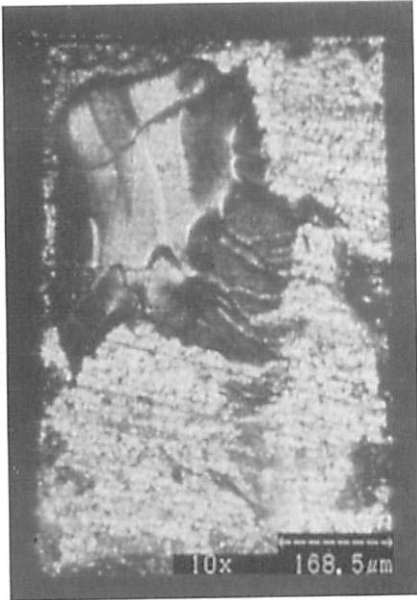
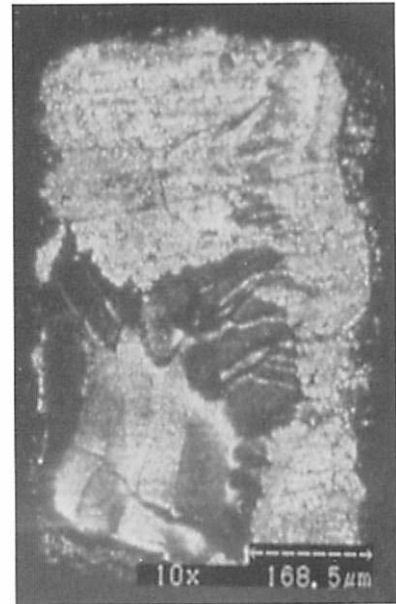
Fig. 4a Representative LSCM micrograph of the upper de-bonded surface of a failed beam from the 2V Pr + Bd subgroup in Group 1, exhibiting >50% adhesive failure at the bonded interface after one year of water storage. (magnification X250)

Fig. 4b Lower de-bonded surface of the same beam as 4a. (magnification X250)

and 3b are representative micrographs of the upper and lower fractured ends of a beam from the 2V Pr sub-group of Group 1 after 1 year, and show complete adhesive failure at the resin-ceramic interface. Figures 4a and 4b are representative micrographs of the upper and lower fractured ends of a beam from the 2V Pr + Bd sub-group of Group 1 after 1 year, and show more than 50% adhesive failure at the resin-ceramic interface. Figures 5a and 5b are representative micrographs of the upper and lower fractured ends of a beam from the P Bd sub-group of Group 1 after 1 year, which exhibit complete cohesive failure within resin. Group 2 exhibited a similar pattern of failure modes to group 1, after 1 day, 1 week, 6 weeks and 1 year of water immersion. In both groups, 2VPr exhibited the highest percentage of complete adhesive failures and P Bd the least, after 1 year of water storage.
